LITIGATION TECHNICAL SUPPORT AND SERVICES

ROCKY MOUNTAIN ARSENAL

FINAL PHASE I
CONTAMINATION ASSESSMENT REPORT
SITE 36-8: CHEMICAL DRAINAGE DITCH

April 1987
Contract Number DAAK11-84-D0016
Task Number 1 (Section 36)
(Version 3.2) ROCKY MC

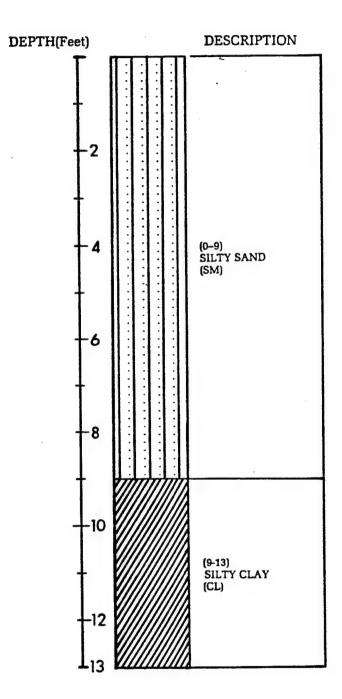
Figure 36-8-2 FIELD BORING PROFILE FOR BORING 3184 SOURCE: ESE, 1987 Prepared for:
U.S. Army Program Manager's Office
For Rocky Mountain Arsenal
Aberdeen Proving Ground, Maryland

Borings 3182 (36-8S) and 3184 (36-8N) encountered ground water at depths of 10 and 12.6 ft below ground surface. Using the top of the boring elevations and the above unstabilized water levels, the elevation of ground water was determined to be approximately 5,233 ft msl at 36-8S and 5,226 ft msl at Site 36-8N. This is in general agreement with the information presented in the Task 1 Technical Plan (ESE, 1985, RIC#85127R07) and the Task 4 data (ESE, 1986c, RIC#86238R08).

Borings 3184 and 3181 encountered water at depths of 12.6 ft and 10 ft respectively. Boring 3184 was in the northern portion and Boring 3181 was in the southern portion of this site.

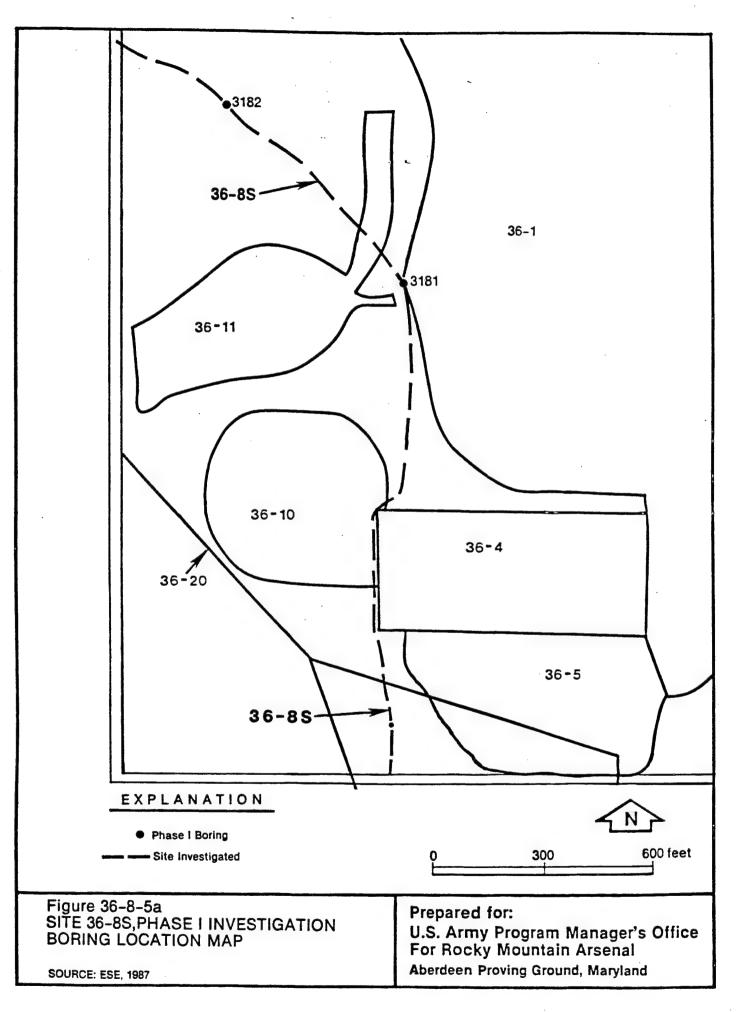
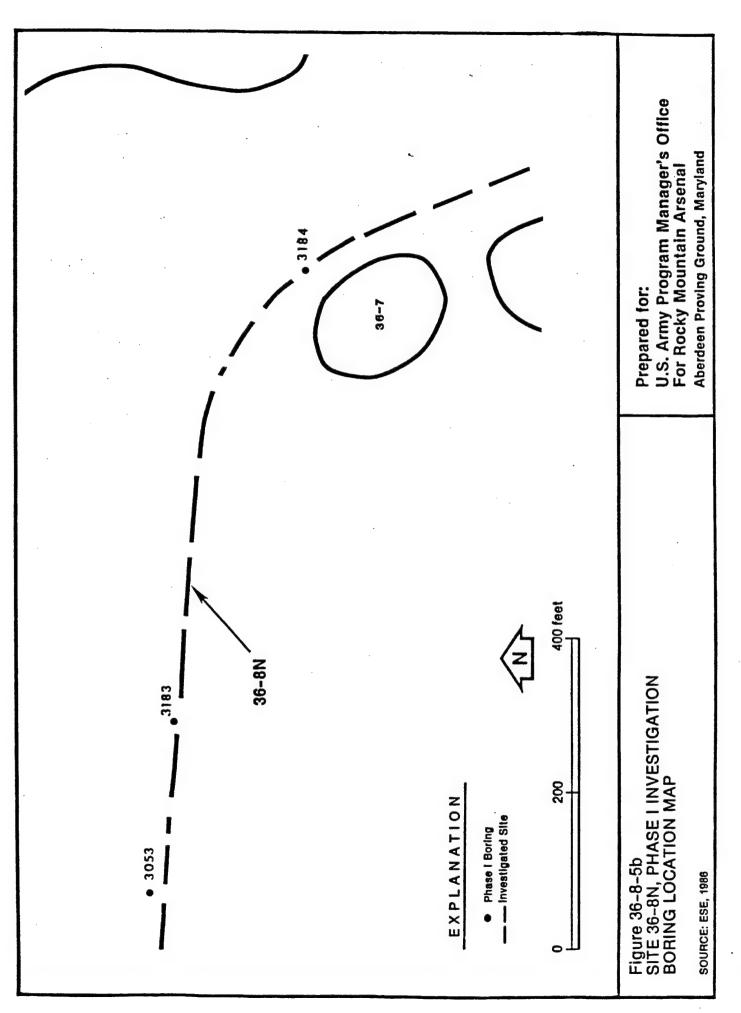
The Phase I investigation at Site 36-8 consisted of drilling a total of 4 borings and obtaining 10 samples for chemical analysis. Borings ranged in depth from 5 to 11 ft. Boring locations are shown in Figures 36-8-5a and 36-8-5b. The site boundaries shown differ slightly from those presented in the Task 1 Technical Plan (ESE, 1985, RIC#85127R07) as a result of modifications made following field reconnaissance and aerial photograph interpretation. A borehole (3053) within the uncontaminated area (Site 36-UNC) located just north of Site 36-8N has been included in the assessment of this site (ESE, 1986b, RIC#87014R21A).

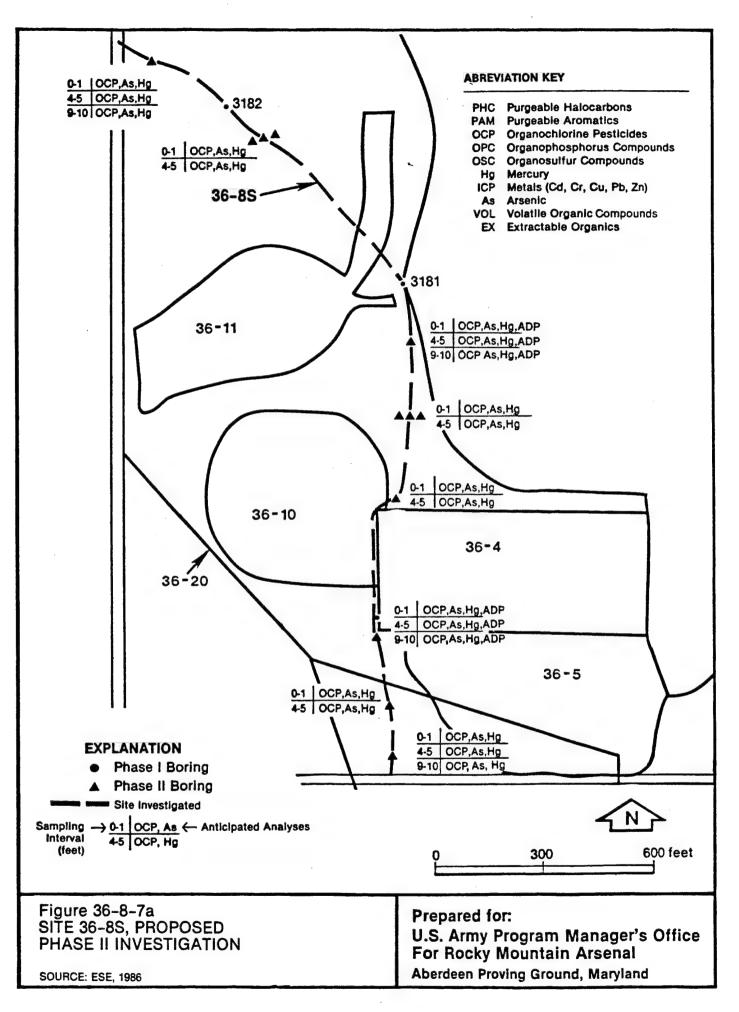
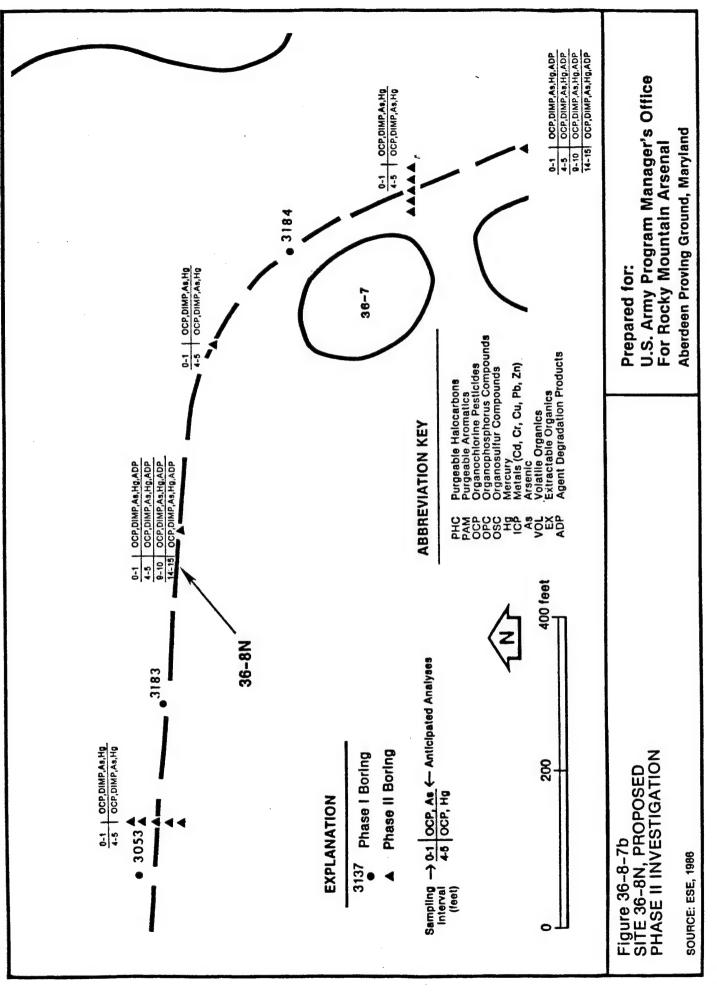
An evaluation of Phase I analytical data and a review of aerial photographs and topographic maps indicate that the boundaries for Site 36-8 do not require modification. However, to determine the lateral extent of possible contamination that could have resulted from the use of these chemical drainage ditches, a width of 50 ft will be investigated in Phase II. Phase II borings will be located within 25 ft of the centerline of each drainage ditch. Three or five borings will be drilled 10 to 25 ft from the center line in a transect perpendicular to each ditch at several locations. These borings will evaluate the lateral dispersion of compounds. Transects consisting of five borings will be drilled in the northern section where earth moving has taken place and the exact ditch alignment is difficult to define. Proposed boring locations and the sampling plan are shown on Figures 36-8-7a and 36-8-7b.

The Phase II sampling plan will consist of a total of 25 borings. Thirteen borings will be drilled along 36-8N and 12 borings will be drilled along 36-8S. A total of six borings will penetrate to the water table. Sampling intervals for Phase II borings will be 0 to 1 ft, 4 to 5 ft, 9 to 10 ft, and 14 to 15 ft. These intervals will be adjusted in the field to ensure that a sample is taken at the same level as the bottom of the ditch. On the basis of the Phase I water table elevations, the total number of samples to be collected in the 25 Phase II boreholes are as follows:

All samples will be analyzed for organochlorine pesticides. Because elevated concentrations of arsenic and mercury were found in the 0 to 1 ft and 4 to 5 ft samples and are widespread throughout Section 36, all Phase II samples will be tested for these elements to verify their occurrence and to supplement the regional investigation for arsenic. As DIMP was only detected in samples taken from the 36-8N ditch, only these samples will be analyzed for DIMP. Specific analyses for Army Agent Degradation Products (ADP) will be conducted on selected samples as shown in Figures 36-8-7a and 36-8-7b.
